HARDWARE ERRATA REPORT

P/N **PCM-052**

phyCORE-Vybrid System on Module

Revision A0, 25 November 2013

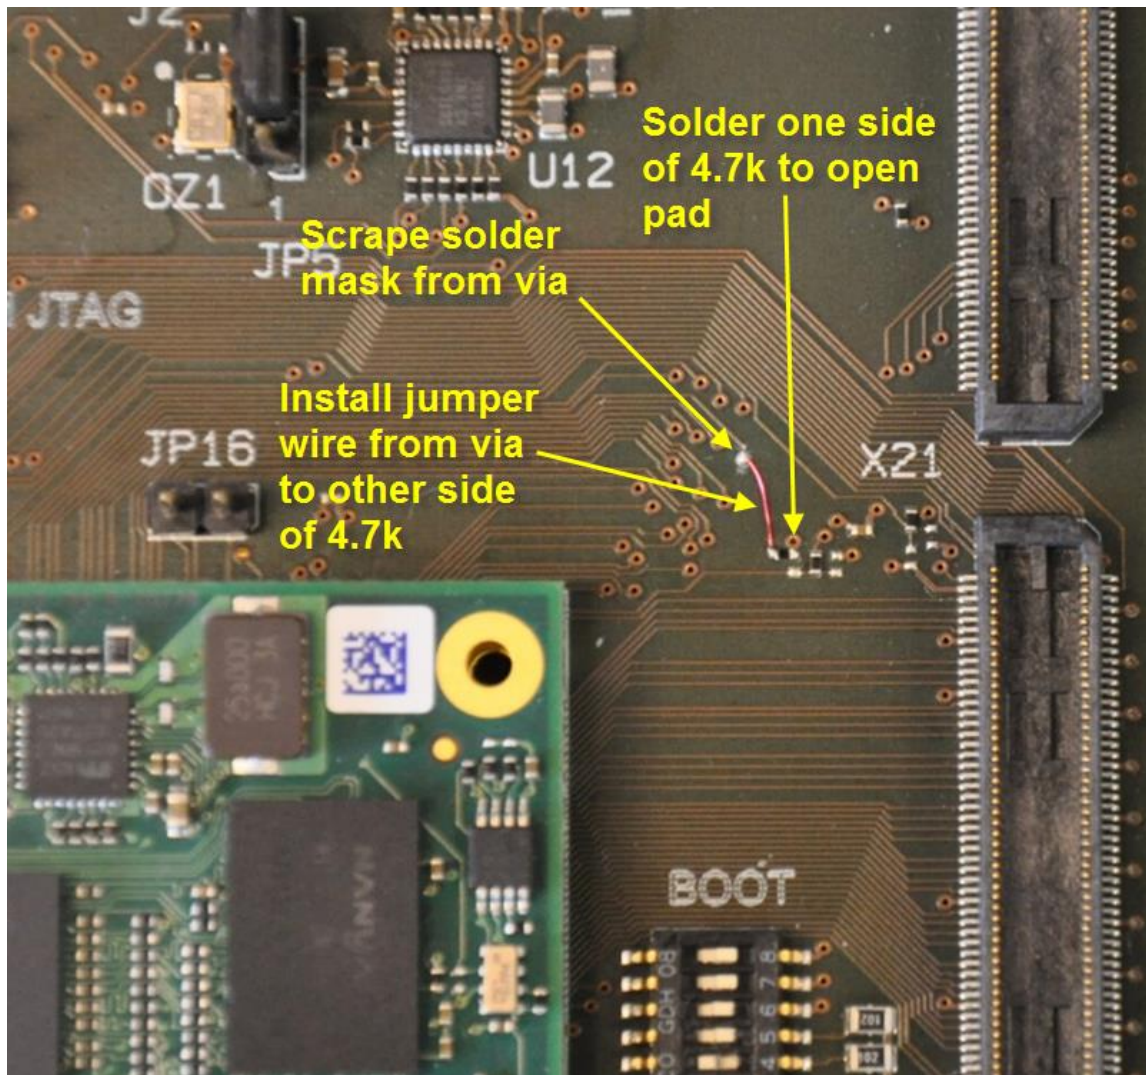
Figure 1: Errata 02 Rework

Errata Impact: The Vybrid ROM loader cannot boot a u-boot image from the NAND device.

Errata Description: The NAND controller's $\text{NFC_R}/\overline{\text{B}}$ by default should be high, putting the NAND flash into a ready state. Instead, $\text{NFC_R}/\overline{\text{B}}$ signal floats at power on. The system reads this as busy, and therefore, not ready for commands.

Workaround: Solder re-work must be done on the phyCORE-Vybrid Carrier Board (PCM-952). Add a 4.7k Ω resistor between $\text{NFC_R}/\overline{\text{B}}$ and VDD_3V3. Figure 1 below, shows a 0402 package 4.7k Ω (1/16 W, 1-5%) resistor soldered to the top pad of R114 (not populated) for a connection to VDD_3V3, which is then connected by a wire to the $\text{NFC_R}/\overline{\text{B}}$ signal available at the respective via.

Errata Fix: 1374.1
